AMMUNITION SAFETY MESSAGE

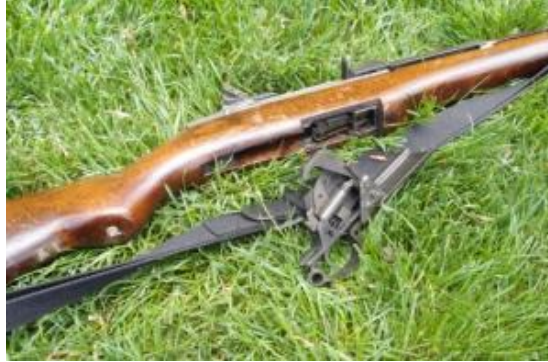
A mishap occurred during the first week of May 2013 in which two M1 Garand rifles blew apart. This occurred during the rendering of honors at the Ohio Western Reserve National Cemetery. As a result of this mishap, two American Legion members received serious injuries. This mishap was caused by the use of .30 caliber grenade launching cartridges instead of the authorized M1909 .30 caliber blank cartridges issued by the US Army Joint Munitions Command. The only visible difference between the blank cartridge and the grenade cartridge is that the blank cartridge has 6 crimps and the grenade cartridge has 5 crimps. The grenade cartridge generates much more pressure and is not designed or intended to be fired with a blank firing adapter.

- **Do not fire .30 caliber grenade cartridge in the M1 Garand Rifle**
- **Only .30 caliber blank ammunition issued by the US Army Joint Munitions Command is authorized for use.**
- **If your ammunition pedigree or origin is questionable, inspect your blank ammunition for the presence of grenade launching cartridges**
